**Flood Control Project Maintenance  
Levee Inspections**

## 2013 Channel Summary Report

## Merced Streams Group

**Flood Control Project Maintenance****Unit Cover Sheet****2013 Channel Inspection Results****Merced Streams Group**

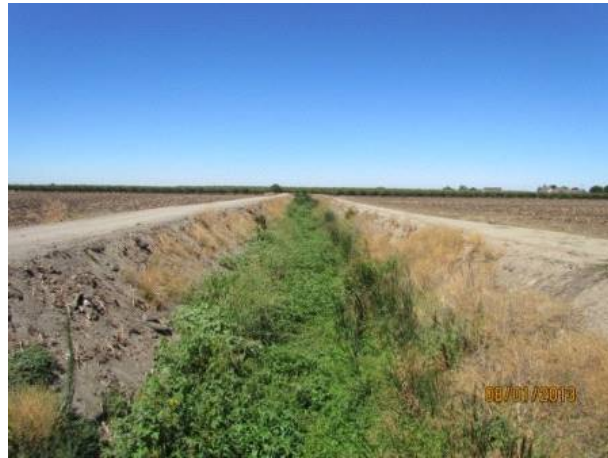
Levee Mile Report Line	46
Start Levee Mile	0.00
End Levee Mile	0.00
Location	
Category	Channels
Item	Vegetation & Obstructions
Downstream view from Whealan Rd. crossing.	
mkhashch_c_20130805_062.JPG

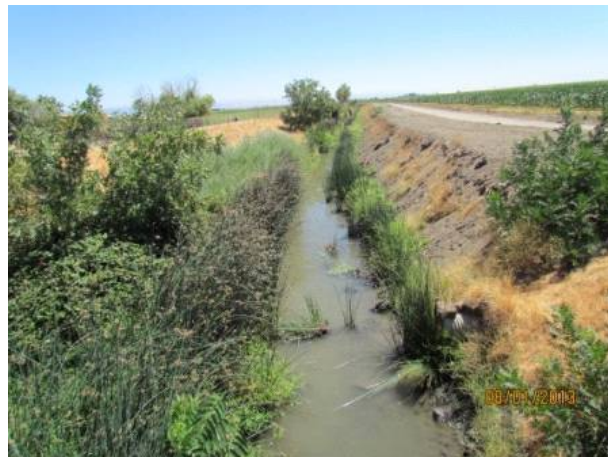
Levee Mile Report Line	51
Start Levee Mile	0.00
End Levee Mile	0.00
Location	
Category	Channels
Item	Vegetation & Obstructions
Upstream view from Arboleda Dr. crossing.	
mkhashch_c_20130805_063.JPG

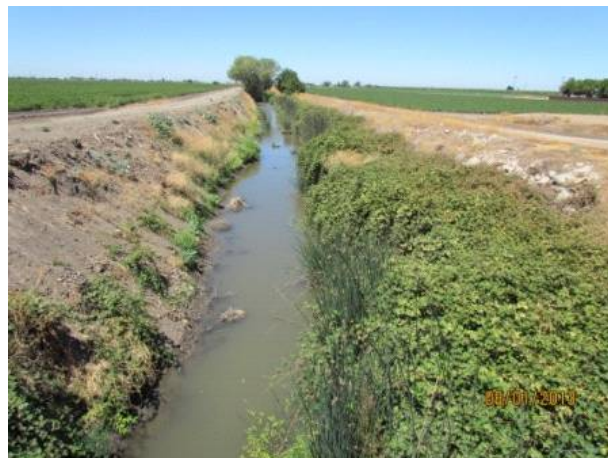
Levee Mile Report Line	56
Start Levee Mile	0.00
End Levee Mile	0.00
Location	
Category	Channels
Item	Vegetation & Obstructions
Downstream view from Arboleda Dr. crossing	
mkhashch_c_20130805_064.JPG

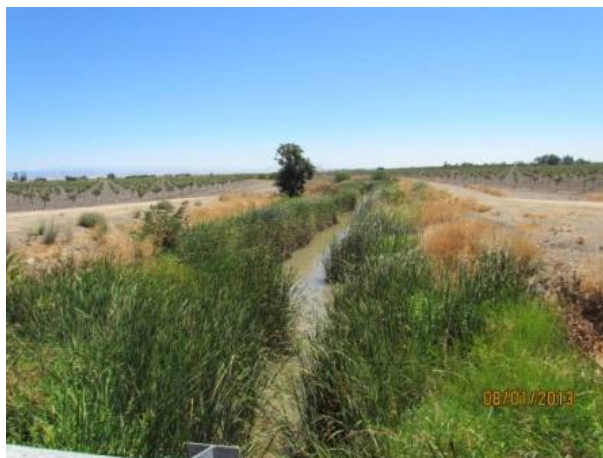
mkhashch\_c\_20130805\_065.JPG

Upstream view from Orchard Rd. crossing.

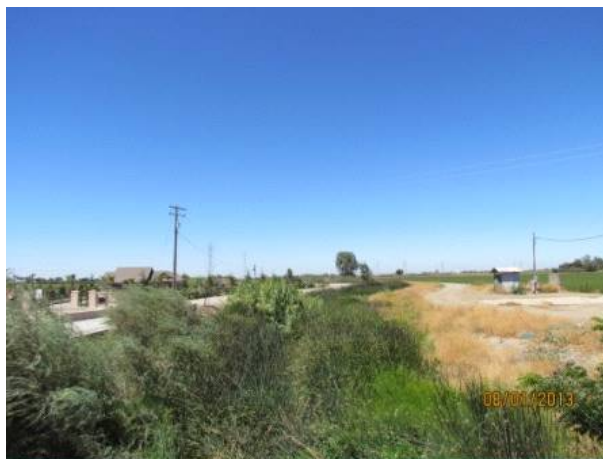
mkhashch\_c\_20130805\_066.JPG

Downstream view from Orchard Rd. crossing.

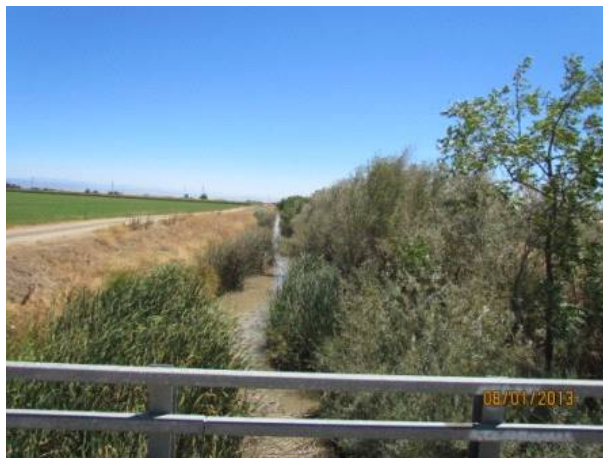
mkhashch\_c\_20130805\_067.JPG

Upstream view from Miles Rd.

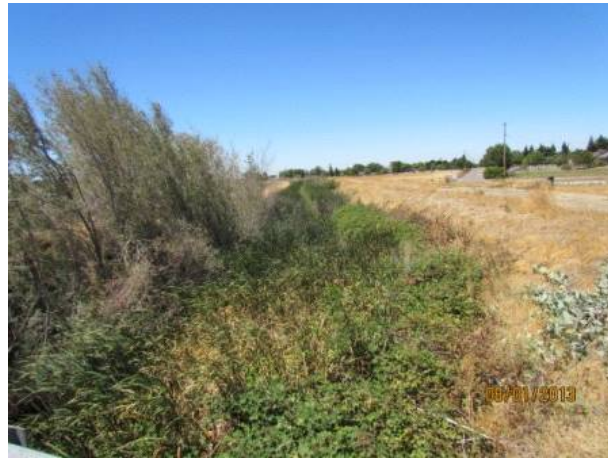
mkhashch\_c\_20130805\_068.JPG

Downstream view from Miles Rd.

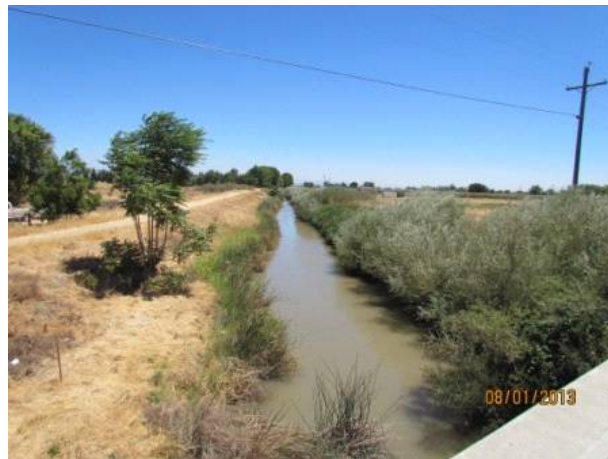
mkhashch\_c\_20130805\_069.JPG

Upstream view from Coffee St.

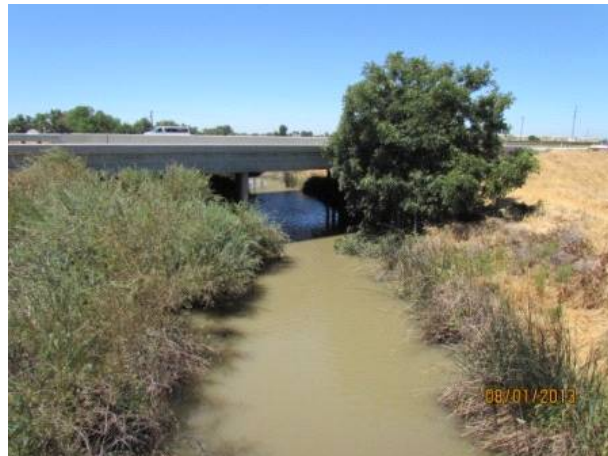
mkhashch\_c\_20130805\_070.JPG

Downstream view from Coffee St.

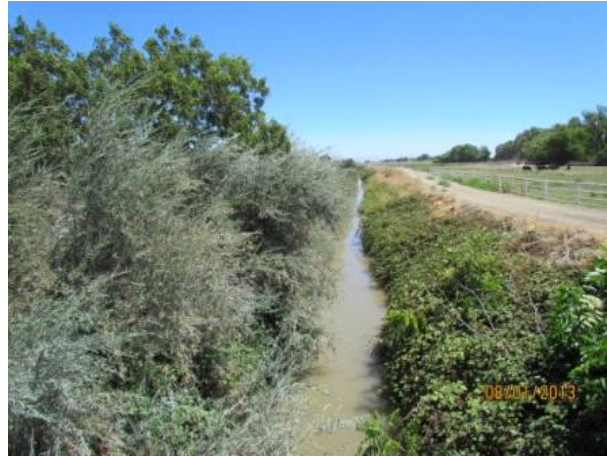
mkhashch\_c\_20130805\_071.JPG

Upstream view from Healy Rd. crossing.

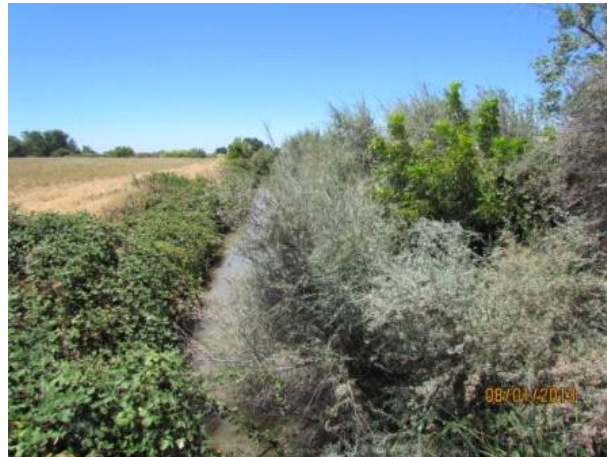
mkhashch\_c\_20130805\_072.JPG

Downstream view from Healy Rd. crossing.

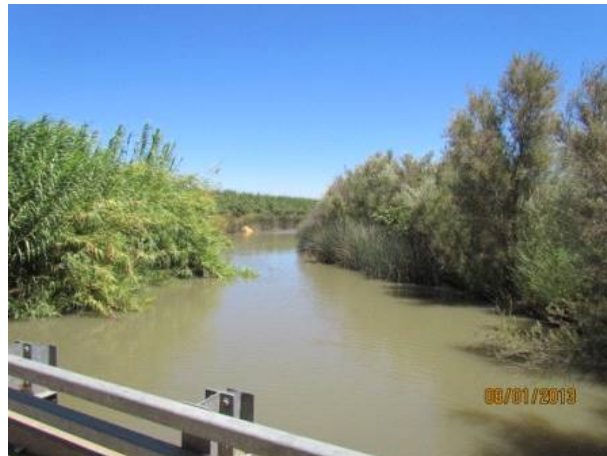
mkhashch\_c\_20130805\_073.JPG

Upstream view from Tyler Rd. crossing.

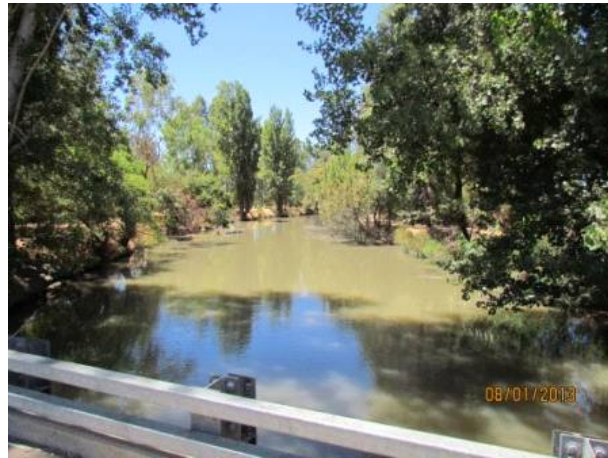
mkhashch\_c\_20130805\_074.JPG

Downstream view from Tyler Rd. crossing.

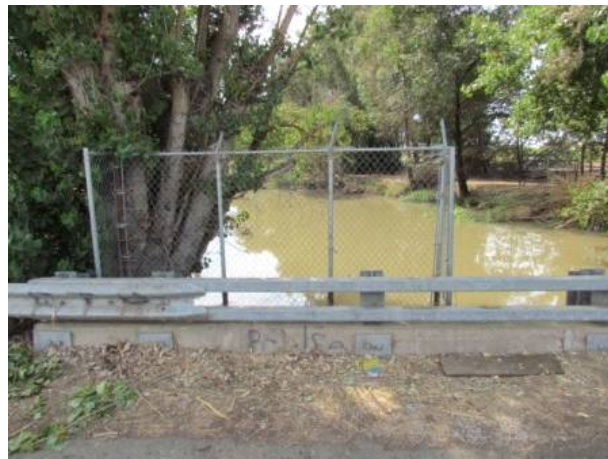
mkhashch\_c\_20130731\_019.JPG

08/14/2012 View of the chain link fence encroaching into the channel on the left bank.

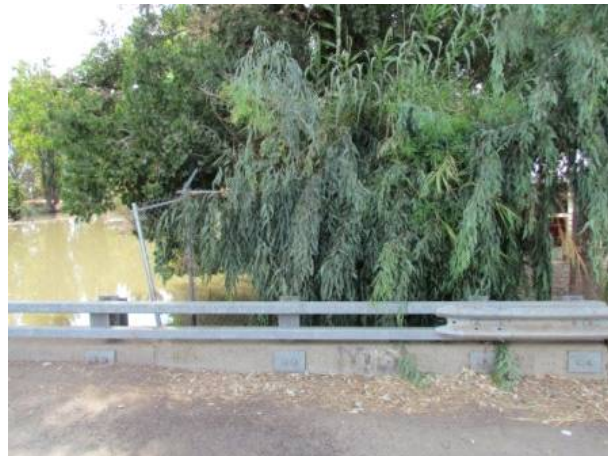
mkhashch\_c\_20130731\_020.JPG

08/14/2012 View of the chain link fence encroaching into the channel on the right bank.

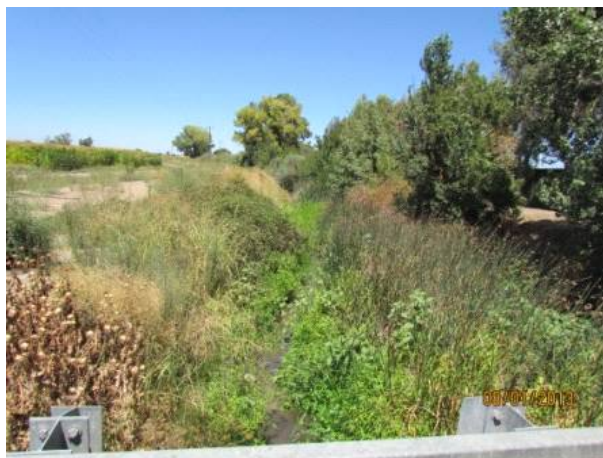
mkhashch\_c\_20130805\_075.JPG

Upstream view from Reilly Rd. crossing.

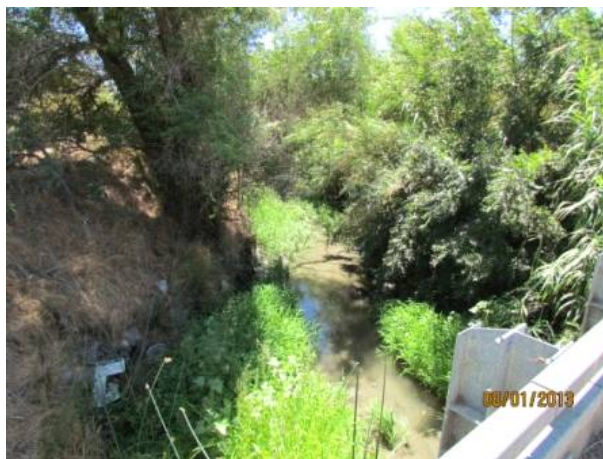
mkhashch\_c\_20130805\_076.JPG

Downstream view from Reilly Rd. crossing.

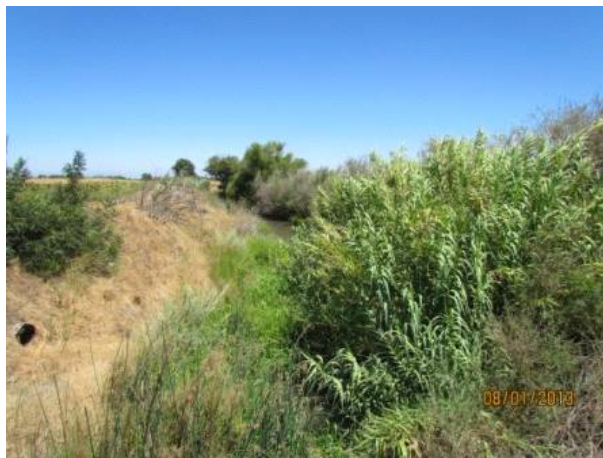
mkhashch\_c\_20130805\_077.JPG

Upstream view from Highway 59 crossing.

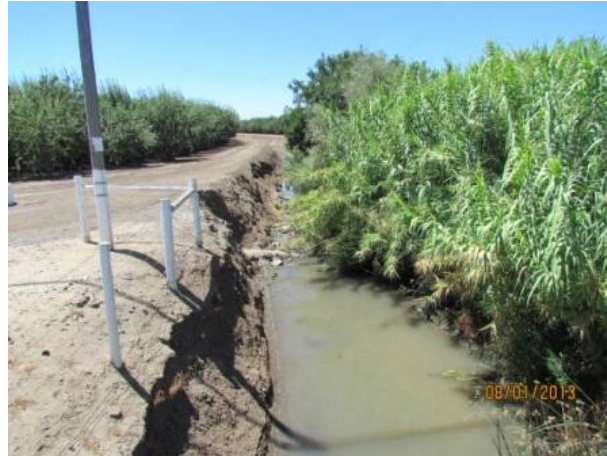
mkhashch\_c\_20130805\_078.JPG

Downstream view from Highway 59 crossing.

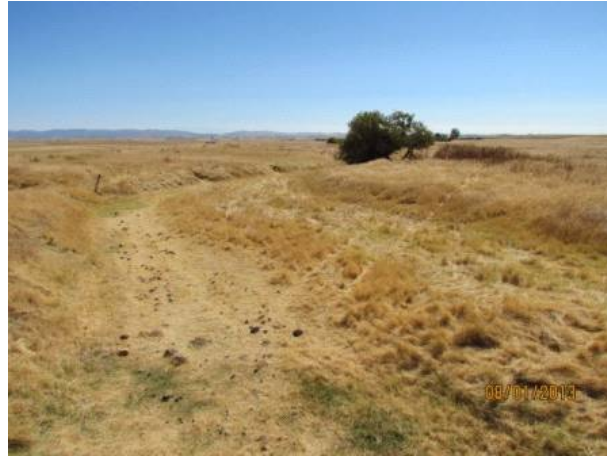
Levee Mile Report Line	1
Start Levee Mile	0.00
End Levee Mile	0.00
Location	
Category	Channels
Item	Vegetation & Obstructions
Upstream view from Cunningham Road crossing.	
mkhashch_c_20130805_041.JPG

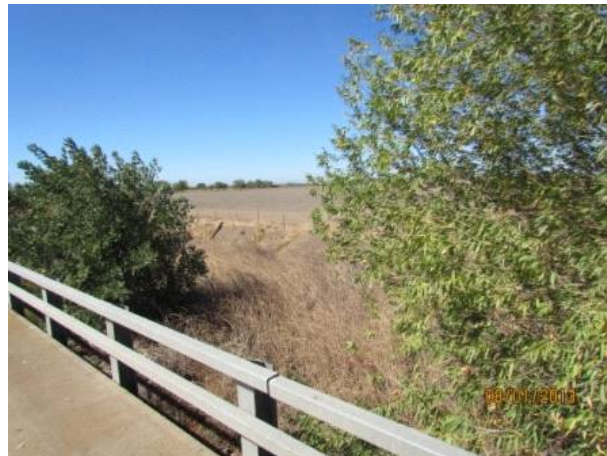
Levee Mile Report Line	6
Start Levee Mile	0.00
End Levee Mile	0.00
Location	
Category	Channels
Item	Vegetation & Obstructions
Cunningham crossing downstream view.	
mkhashch_c_20130805_043.JPG

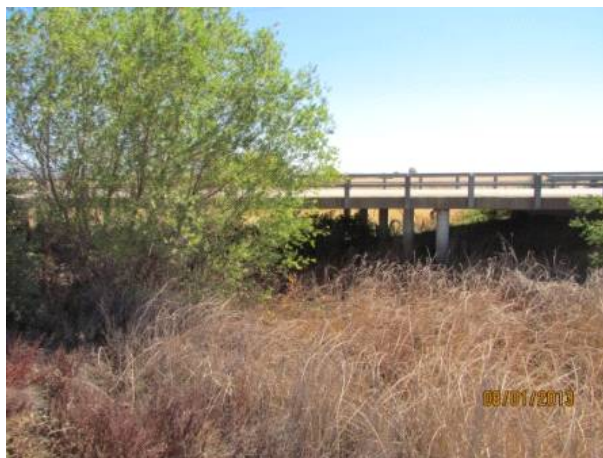
mkhashch\_c\_20130805\_044.JPG

Debris and vegetation accumulated under bridge.

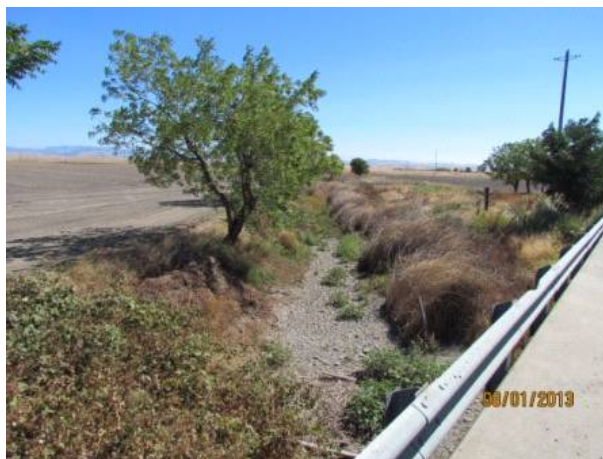
mkhashch\_c\_20130805\_045.JPG

Upstream view Childs Ave. crossing.

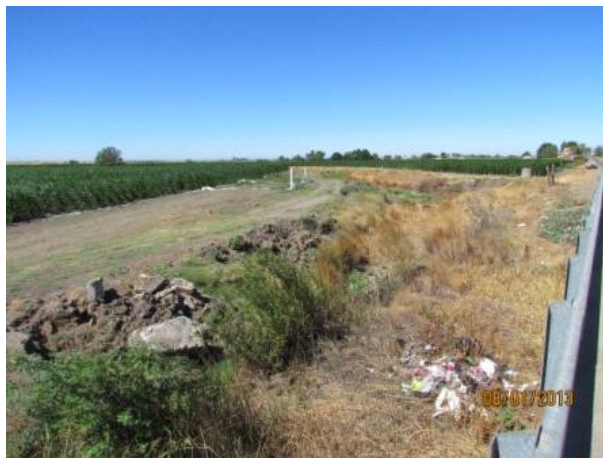
mkhashch\_c\_20130805\_046.JPG

View of downstream channel at Childs Ave.

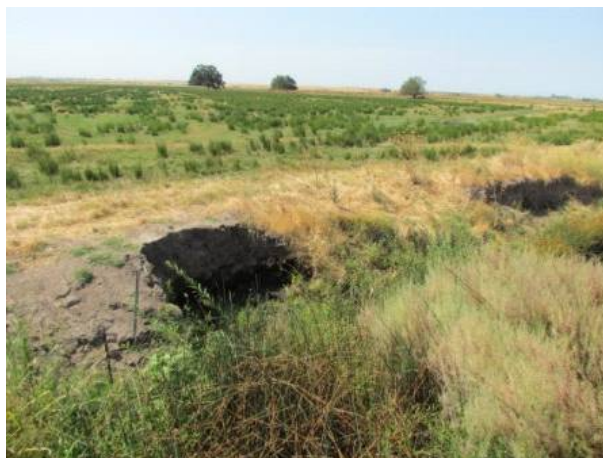
mkhashch\_c\_20130731\_032.JPG

08/14/2012 View of bank caving.

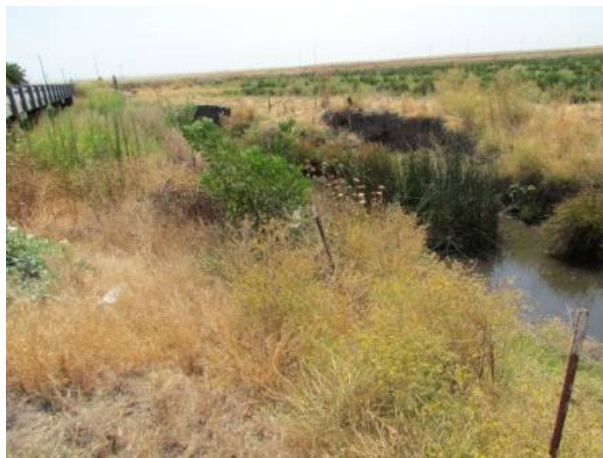
mkhashch\_c\_20130731\_033.JPG

08/14/2012 Wire fence across channel downstream of Childs Ave. crossing.

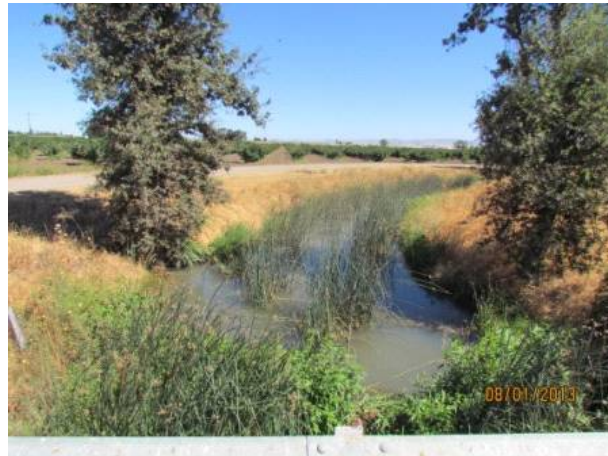
mkhashch\_c\_20130805\_048.JPG

Upstream view from Mission Ave. crossing.

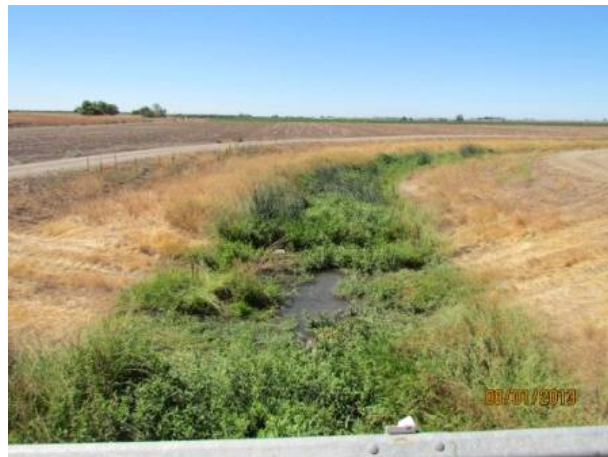
mkhashch\_c\_20130805\_049.JPG

Downstream view from Mission Ave. crossing.

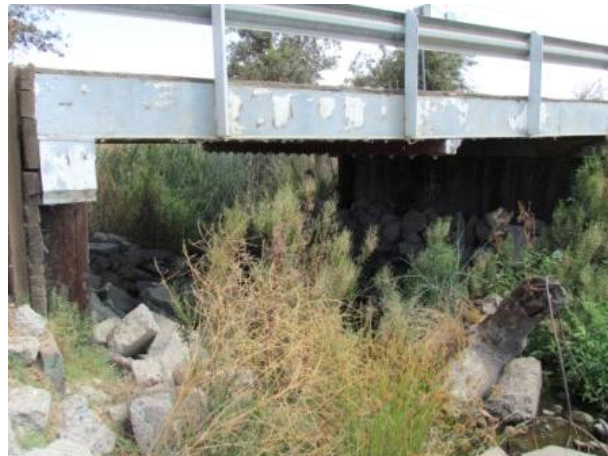
mkhashch\_c\_20130731\_036.JPG

08/14/2012 Mission Ave. crossing rip rap shown in channel.

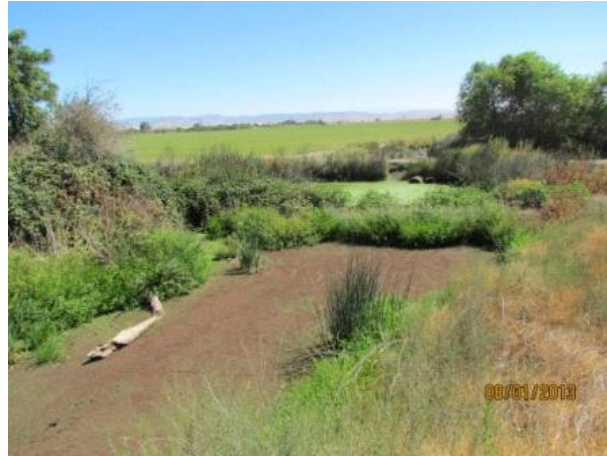
Levee Mile Report Line	31
Start Levee Mile	0.00
End Levee Mile	0.00
Location	
Category	Channels
Item	Vegetation & Obstructions
Upstream view of Owens Creek at diversion.	
mkhashch_c_20130805_050.JPG

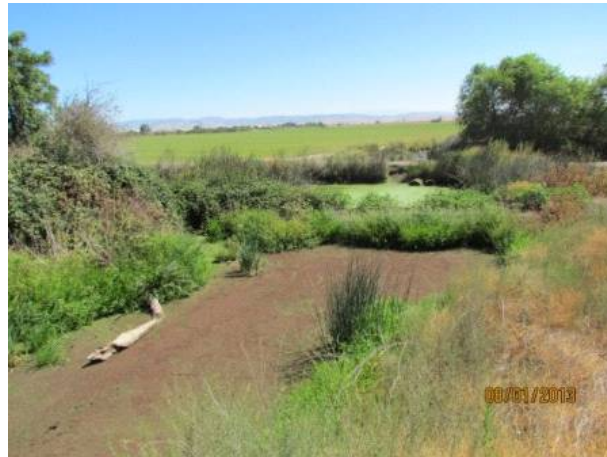
Levee Mile Report Line	35
Start Levee Mile	0.00
End Levee Mile	0.00
Location	
Category	Channels
Item	Encroachments
Photo shows what appears to be material placed in the channel, material is overgrown with vegetation.	
mkhashch_c_20130805_051.JPG

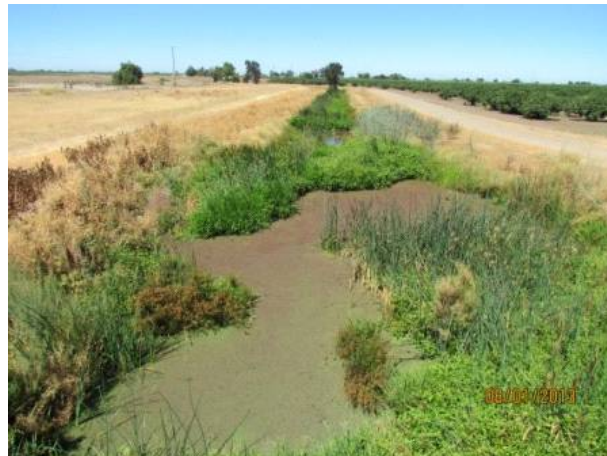
Levee Mile Report Line	36
Start Levee Mile	0.00
End Levee Mile	0.00
Location	
Category	Channels
Item	Vegetation & Obstructions
View of downstream from the diversion.	
mkhashch_c_20130805_052.JPG
